Installation – Wall Cladding Application

Installation – Roof Sheeting Application

Oil Canning

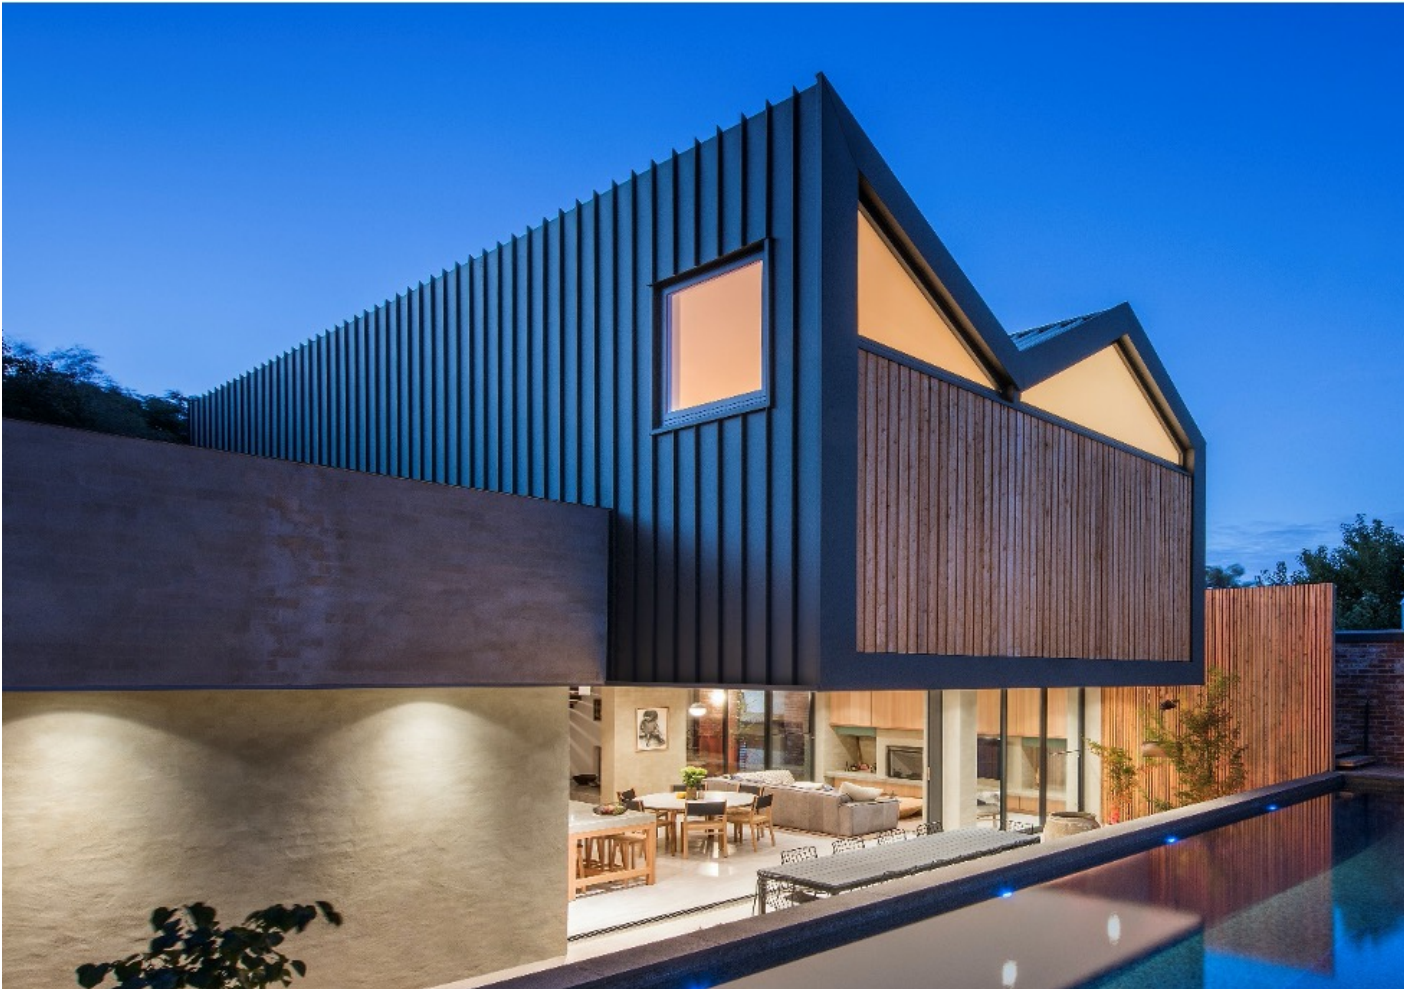
Oil Canning is an inherent characteristic of metal wall cladding and roof sheeting which have broad flat areas; oil canning is often the term given to distortion or waviness in the pan of the sheet.

There are measures that can be taken during design and installation to minimise the risk of oil canning such as ensuring the substrate is flush, the panels are fixed vertically, limiting the continuous length of each panel, and choosing an installer who has experience with installing architectural profiles. Knowledge of thermal movement, material performance, and installation techniques are critical for aesthetic performance of the profile.

Despite the above measures Revolution Roofing cannot guarantee that oil canning will be eliminated because it can also be caused in the manufacture or slitting of the flat coil, manual handling during Production or Installation and by the ambient temperature at the time of installation, or viewing of the profile.

The functional performance of the SnapLock Panel is not compromised by oil canning and as such will not be a reason for rejection of the panels.
